INSPECTION REPORT

21000 Wood Loop 3, Wood, South Carolina 29376

Inspection Date	Dec 31, 2021
Company	Prime Palmetto Home Inspections, LLC
Inspector	Quincy Barrett
Client

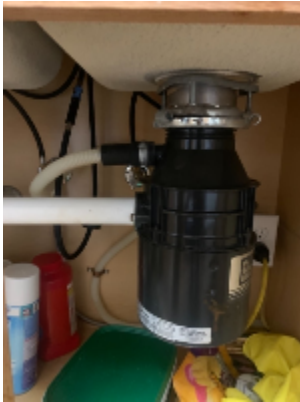
## ! DISHWASHER

### Missing high drain line loop

Without a high drain line loop, risk of a potential backflow of water in to the dishwasher and improper drainage of water is increased

Position drain line to create a high loop ensuring the highest point of the drain line is above the entry point of the drain entrance

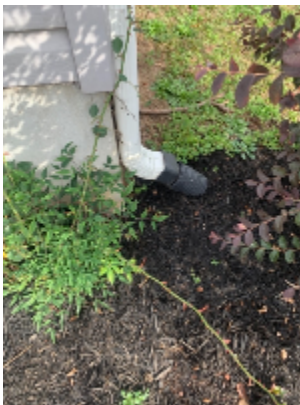
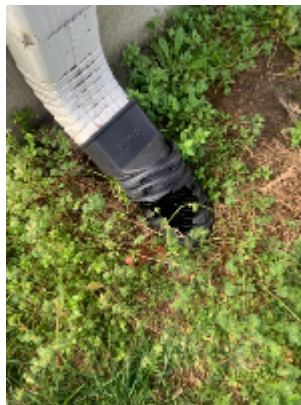
## ! DOWNSPOUT

**Downspout extensions are damaged.**

Recommend repair/replace to help control distribution of water away from home.

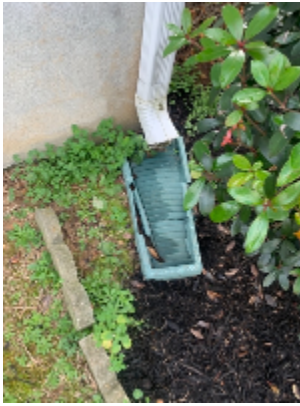
**Splash-blocks are damaged.**

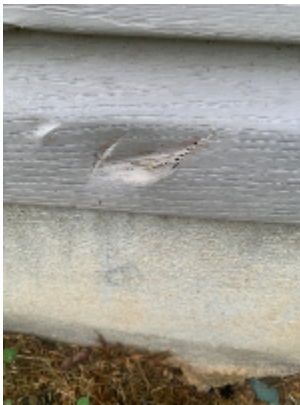
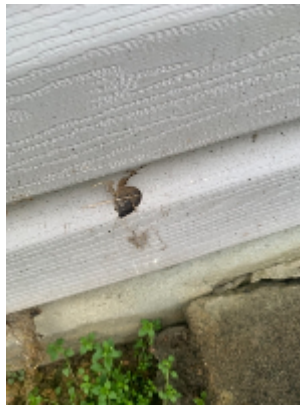
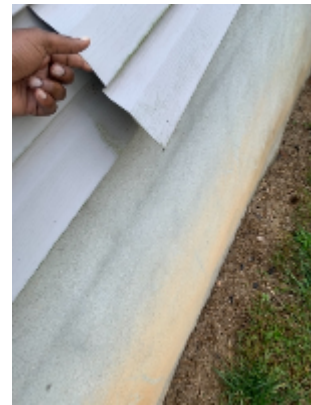
**Minor damage to siding material.**

With damaged siding, the home lacks protection from insects, animals and the elements and it may negatively affect the thermal boundary of the home

Replace/Repair the damaged area

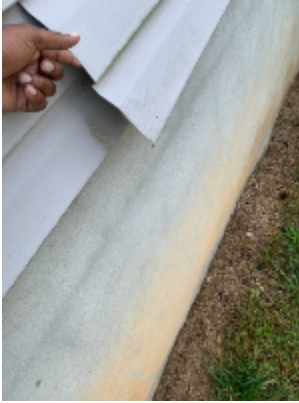
**Loose**

Without siding, protection from elements is lacking

Resecure or replace the siding if it can not be secured

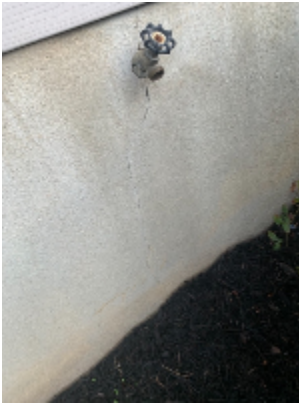
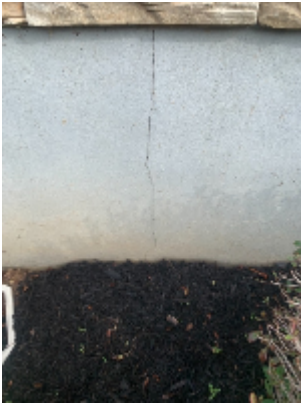
<b>OBSERVATION TO MONITOR</b>	<b>Exhibits hairline vertical cracking</b>
<b>IMPACT</b>	The cracking may worsen allowing moisture intrusion
<b>SUGGESTED ACTION</b>	Monitor for further cracking. If the cracks widen have epoxy injected into the crack by a licensed waterproofing contractor
<b>PHOTOS</b>

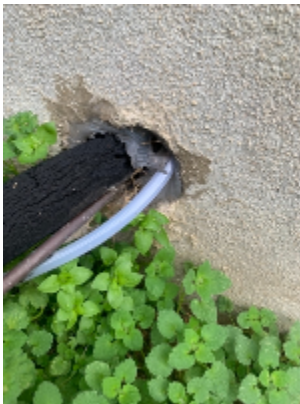
Opening for refrigerant line should be resealed to avoid insect and water from getting inside crawl space.

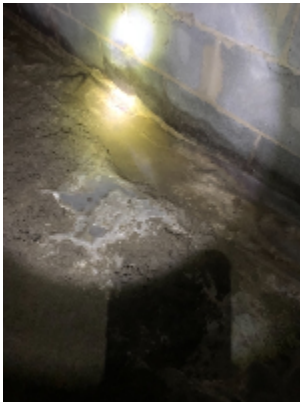
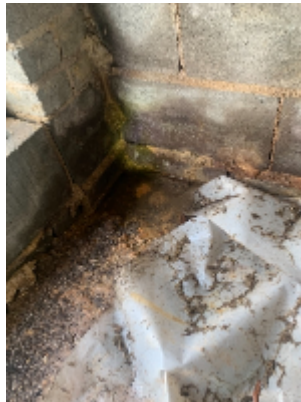
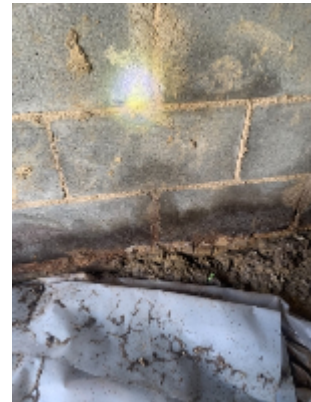
Crawl space is missing moisture barrier in many areas underneath home.

The purpose of a vapor barrier is to block vapors and moisture in the soil from getting into your crawl space. Without a proper secured moisture barrier, it can create an environment for mold/mildew growth and wood rot.

Replace or repair moisture barrier.

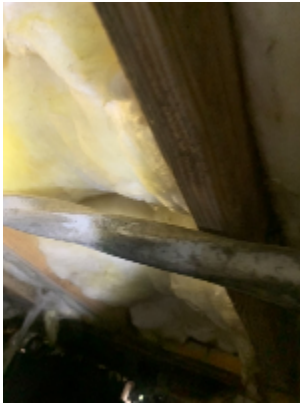
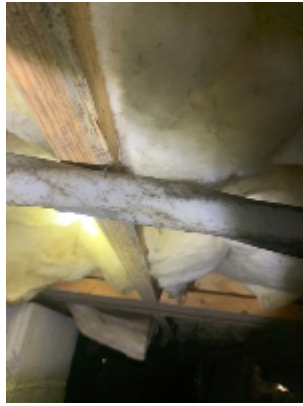
Signs of mold/mildew growth in crawl space.

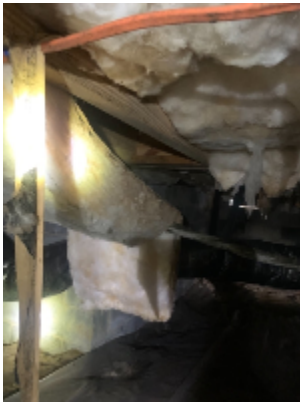
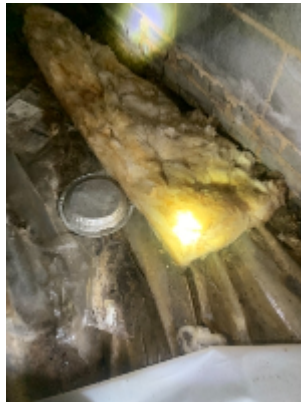
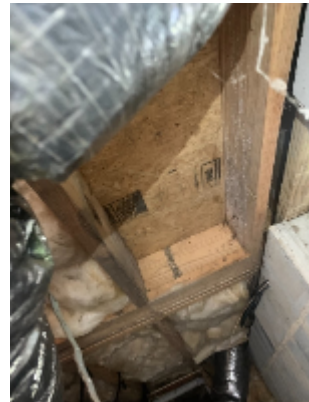
Missing insulation in some areas of the crawl space under the wood components of the home.

Without insulation, the thermal boundary is incomplete causing the loss of heating and cooling and increasing utility costs

Add insulation

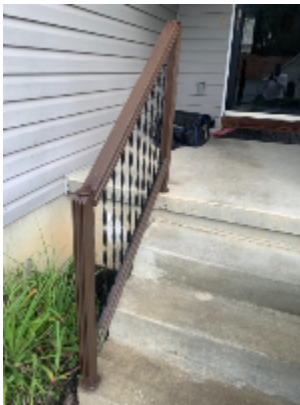
### Handrail and baluster loose on front entry porch

A loose handrail could hinder the stair user an opportunity to stop or reduce the extent of a fall

Resecure the handrail ensuring stbility with either longer screws or relocate the brackets

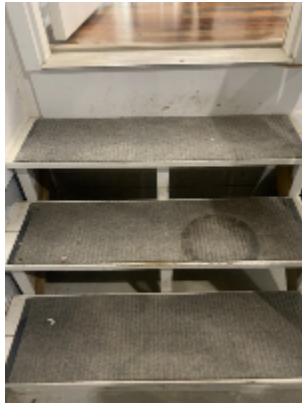
### Open risers in garage stairs.

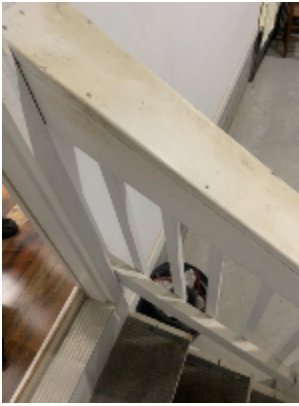
**Handrails in garage are not graspable.**

Graspability of a handrail refers to the ability to get a secure hold onto a handrailing whose purpose, after all, is both to guide a walker along a stair or other surface and to prevent or perhaps to interrupt slip trip and fall hazards.

Recommend replacement of handrails.

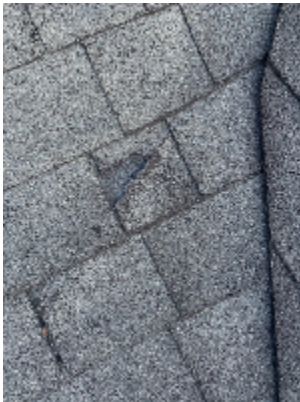
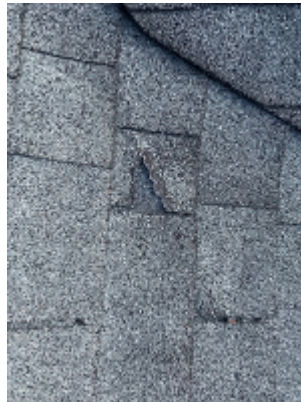
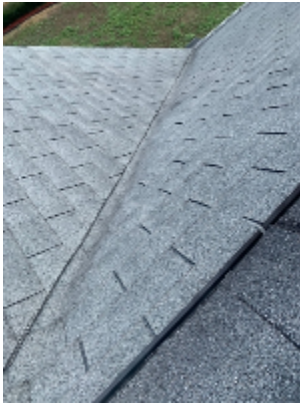
**Damaged in isolation areas.**

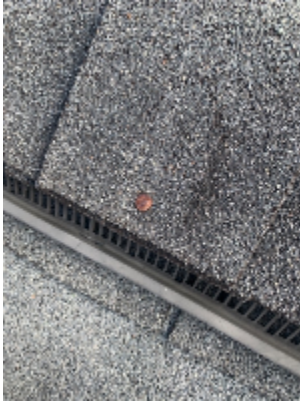
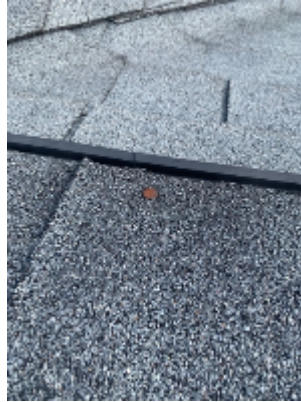
**Exhibits nail popping and/or exposed nail heads**

If left unattended, the roofing system will be compromised, and water could penetrate the wood causing leaks and interior damage

Nail pops can be caused by a variety of reasons. When the temperature changes, expansion and contraction can cause the nails to pop up and lift the shingles. It may also be caused by inadequate ventilation. Other causes

of nail pops can be that the shingles were not nailed tightly when the roof was installed

"Replace the popped nail with a new nail 1" higher than the existing hole. Make sure to apply roofing cement to cover the existing nail hole"

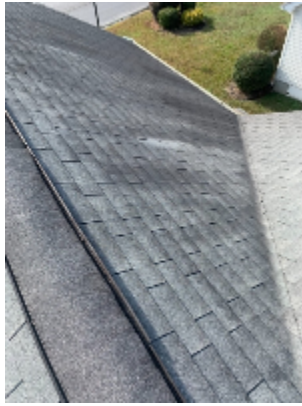
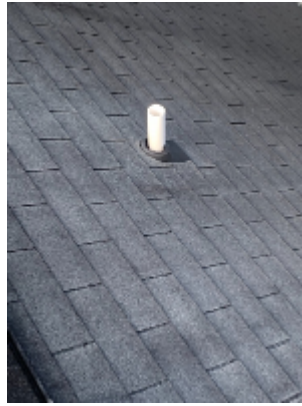
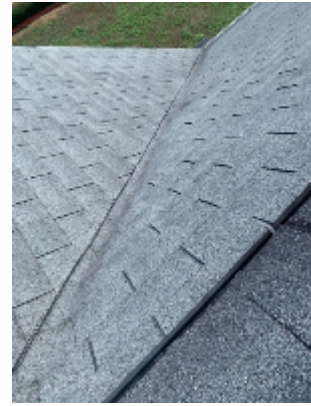
**Nearing the end of its useful life**

Budget for a newer unit. In the interim, a higher level of maintenance can be expected

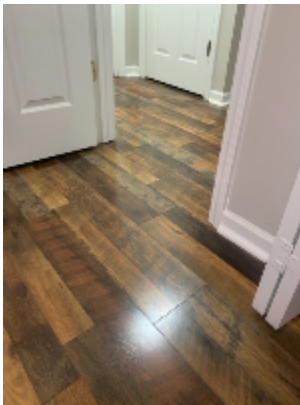
Floor in guest bedroom appears to have hump near entry door.

Recommend license contractor for further evaluation.

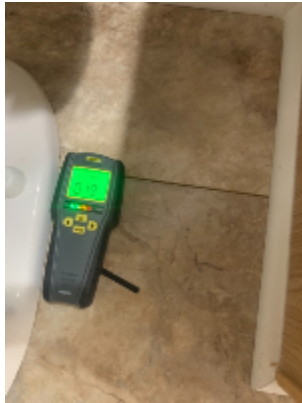
Flooring around toilet in guest bathroom has higher than normal moisture reading.

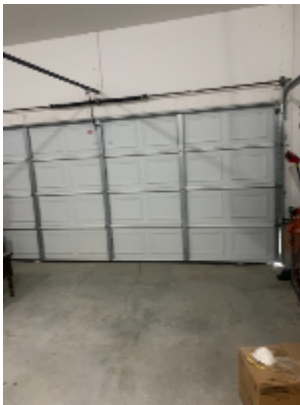
Eye sensors on overhead garage door is too high. It should sit no more than 6 inches from the ground.

Adjust eyes sensors to correct height.
